# Manhole Inspection Summary

Manhole # S19MM\_002MH

Insp Date: **7/3/07 11:36 AM**

**Location** Address: **1915 WINDSOR AVE**

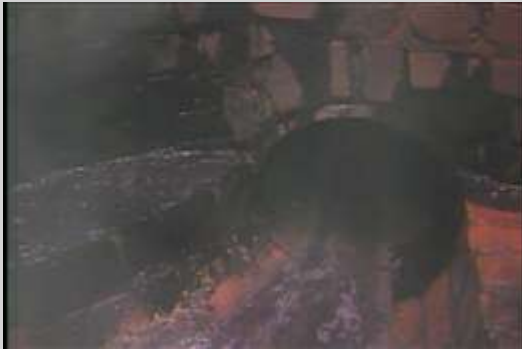
12 O'Clock Outflow

12 in. Circular Gravity Sewer  
Pipe Out @ 12 O'Clock

Pipe Height: **12** (in.) Rod and Bar (Angled)  
Pipe Material: **Clay** ☐ Pipe Lined  
Invert Depth: **11.04** (ft.) Flow Characteristics: **Slow**  
Deposits: ☒ None ☐ **Mud** ☐ Sludge ☐ Debris ☐ **Grease**  
Silt Depth: (in.) Deposits Extent:  
Infiltration: **None** Pipe Seal Cond: **Sound**
